TUNNEL INSPECTION REPORT

ST. ELIZABETHS HOSPITAL – WEST CAMPUS
WASHINGTON, D.C.

Report Prepared by:
Burgess & Niple, Inc.
4160 Pleasant Valley Road
Chantilly, VA 20151

Date: February 2006

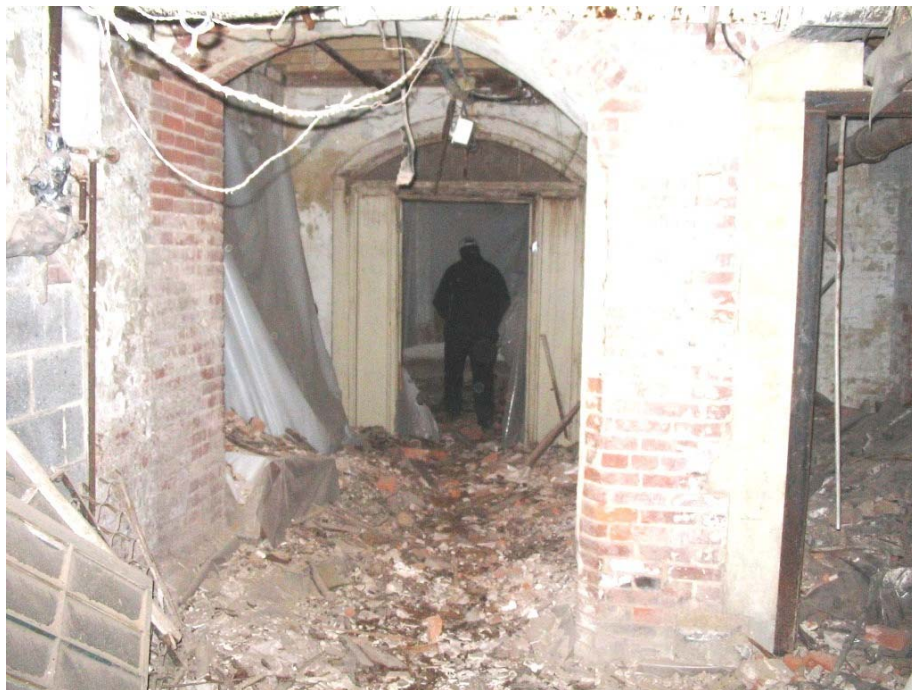
Photo 6: Heavy debris on floor; Note hanging wiring

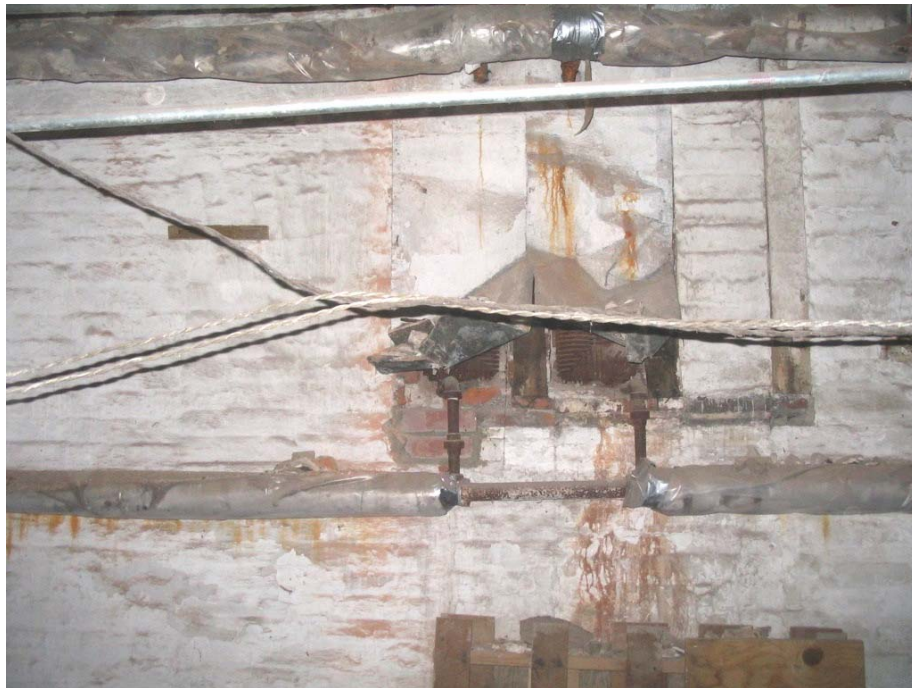
Photo 10: Corrosion on steam pipe, south wall

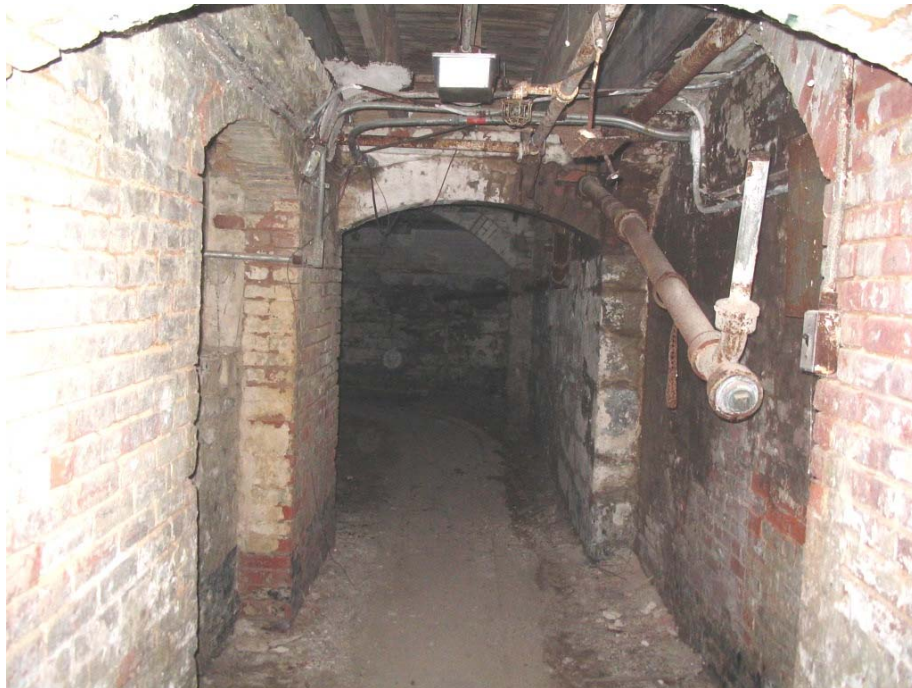
Photo 8: Hanging pipe near west end; Note corrosion on piping and conduits

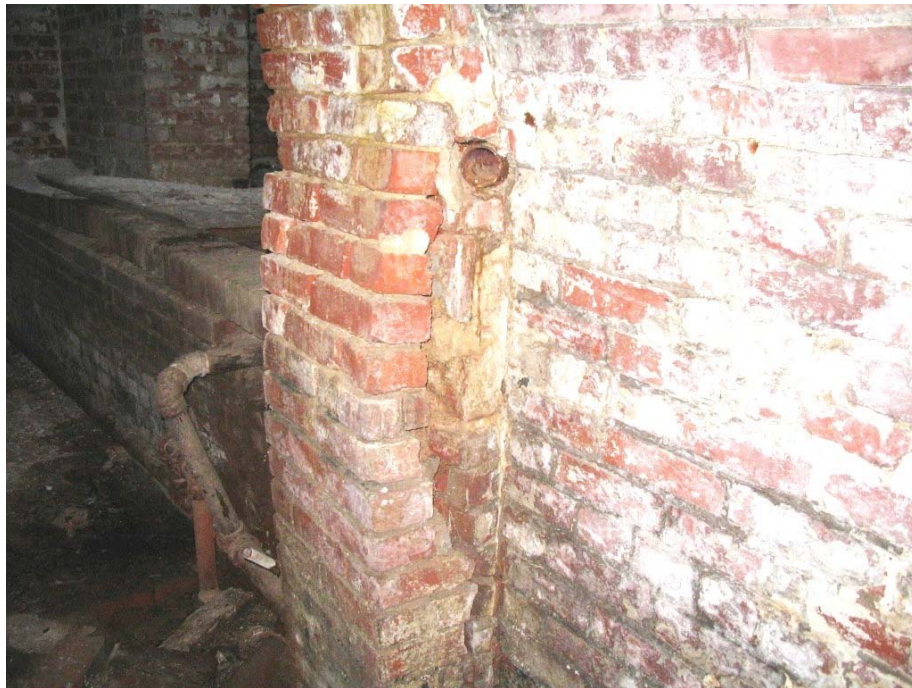
Photo 6: Deteriorated mortar joints on west wall of south portal, looking south

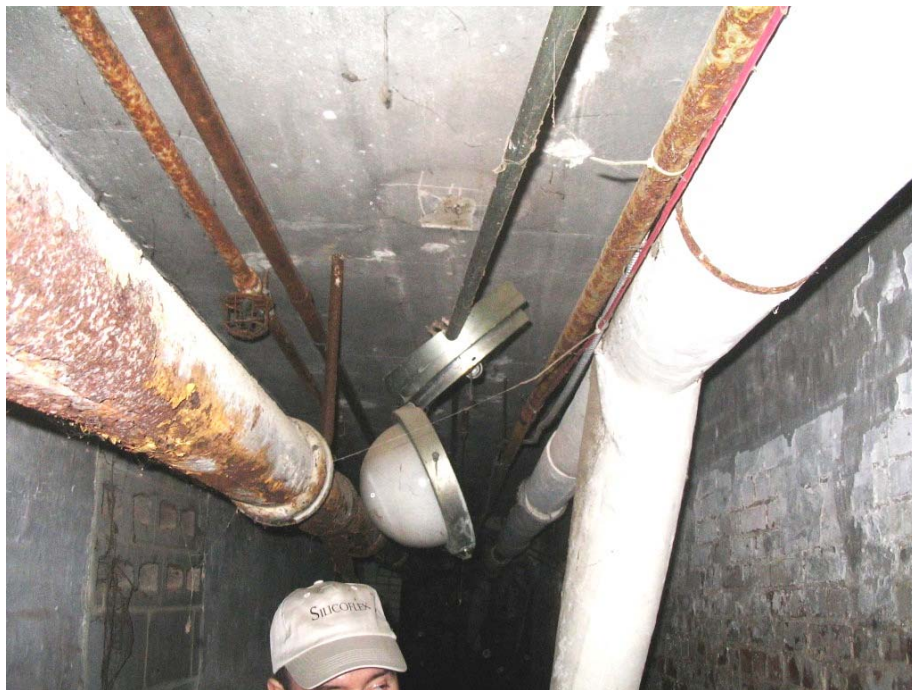
Photo 6: Damage light fixture; Note corrosion on pipe and conduits

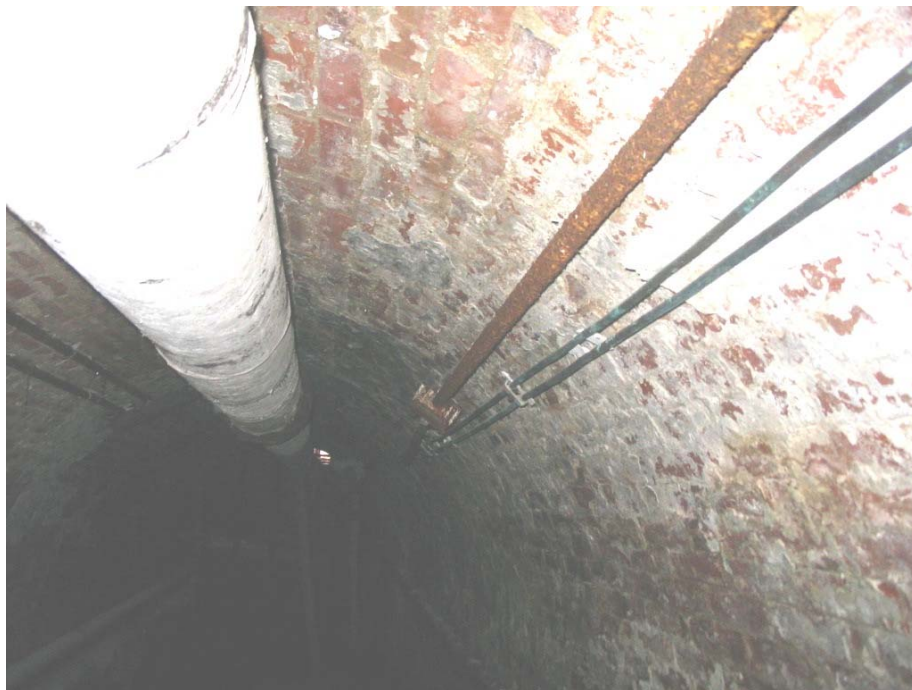
Photo 8: Typical corrosion on lighting conduit

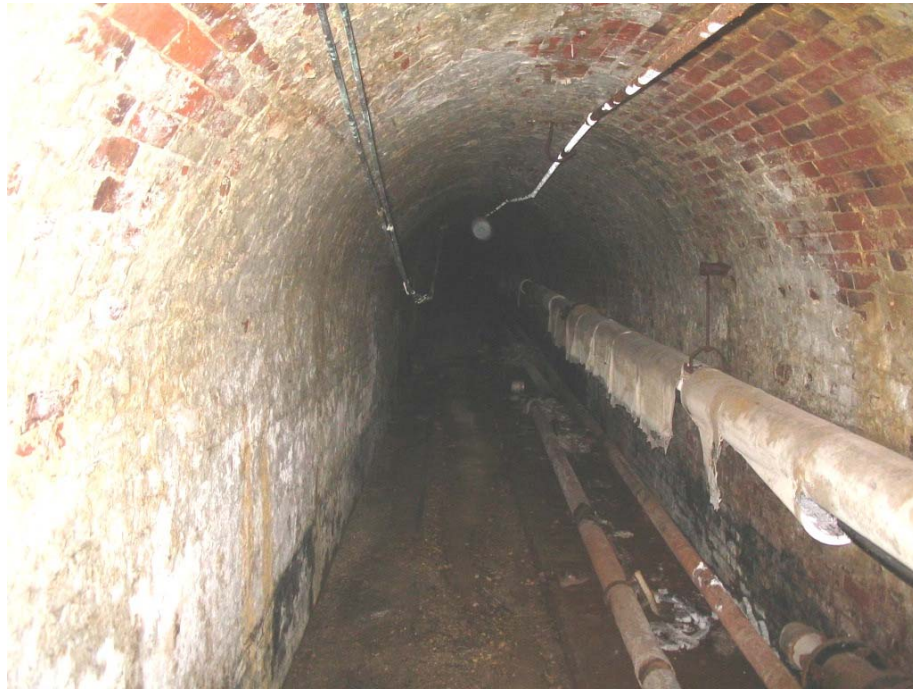
Photo 3: General view looking east from elbow below Building 44;
Note debris on floor and corrosion on pipes

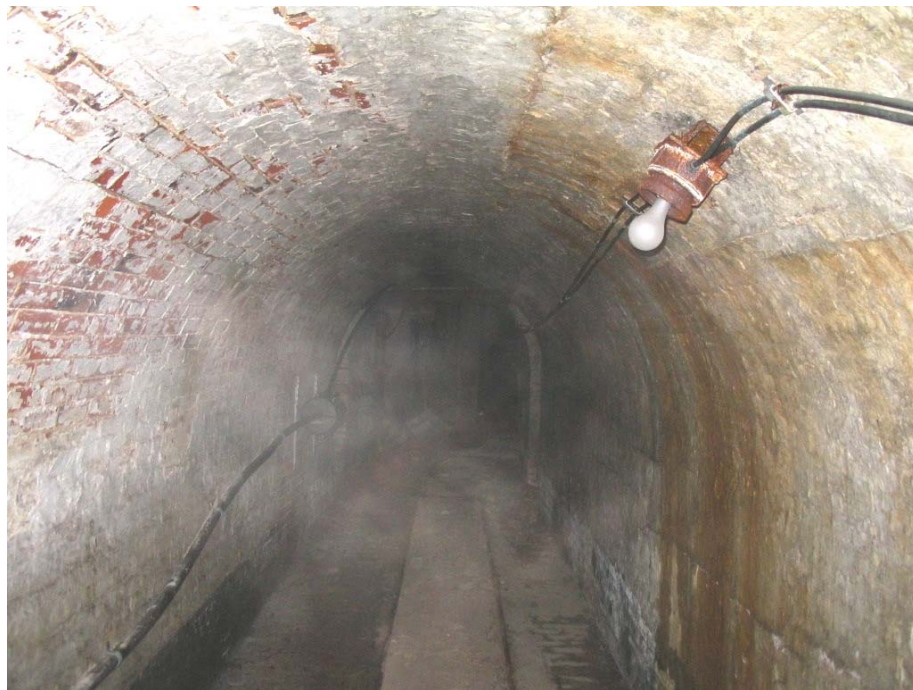
Photo 4: General view near west end; Note sagging cables

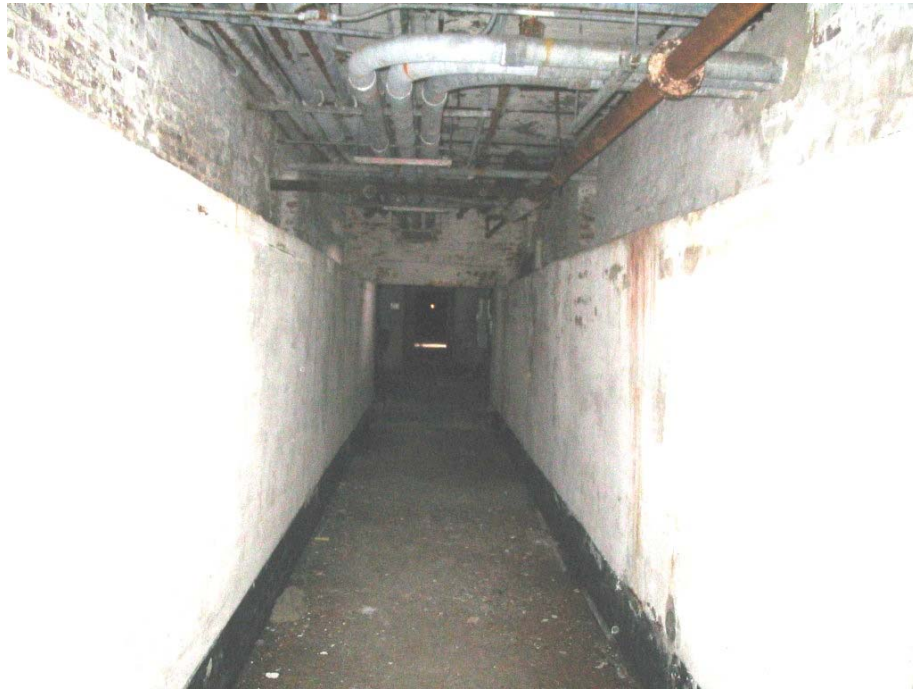
Photo 5: Corrosion on utility pipes

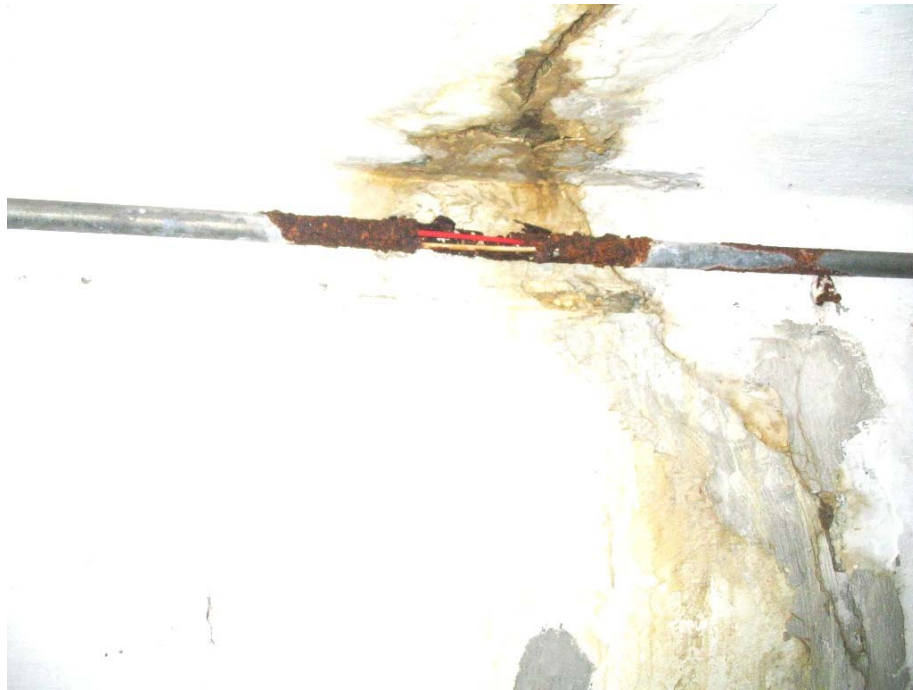
Photo 6: Deteriorated conduit with total section loss; Note exposed wires
